Retaining Wall & KP 11.3

File No. : 4-SON-116-KP 11.3
Location 2 - (PM 7.0)
4277-1S3001
Slipout

Subject : Slide Repair Foundation Recommendations

Subject: Corrosion Review for Route 116 Slide Repair

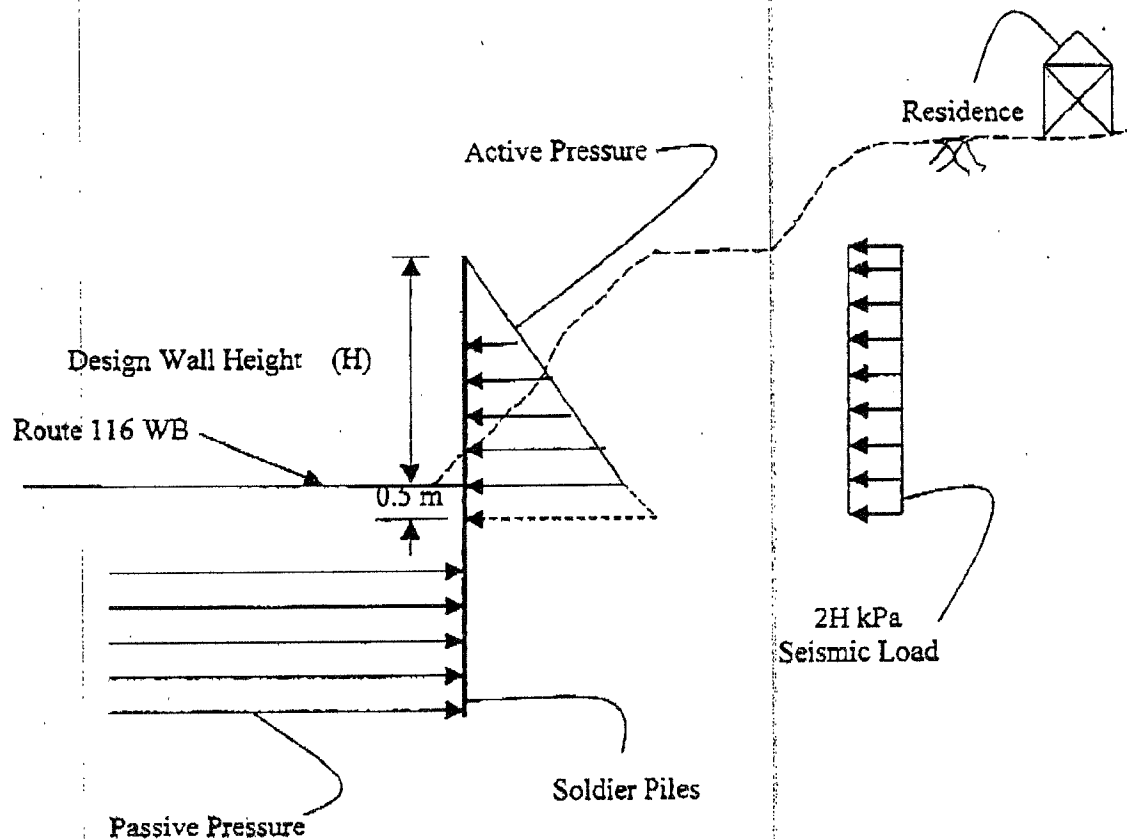
Figure 1 - Pressure Diagram

- a. A triangular pressure diagram from the top of the wall to about 0.5 m below the dredge line of the wall as shown on Figure 1 below. Use an equivalent fluid pressure of 5.5 kN/m^3 per 0.3 m of depth (based on an internal friction angle $\phi = 34^\circ$ for the structure backfill behind the wall with unit weight $(\gamma) = 18.85 \text{ kN/m}^3$ (120 pcf).
- b. A uniform pressure diagram of $2H \text{ kPa}$ for seismic loading assuming an average horizontal acceleration of $0.5g$. See Figure 1 below.
